'Bringing 21st century ventilation solutions to your home'

A visualisation of the movement of air in an unvented dwelling!

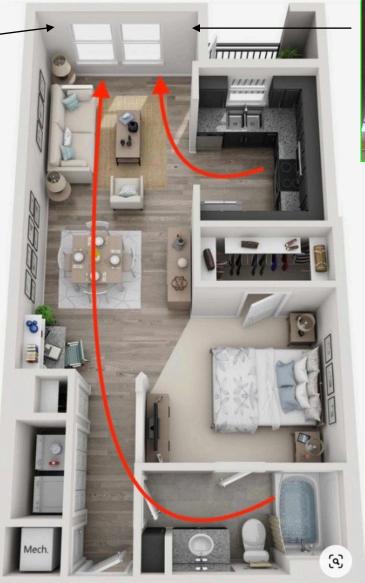
The arrows demonstrate the air flow of a non ventilated dwelling and illustrate how warm moist air created from cooking and bathing can move to the cooler parts of the property.

As external temperatures drop, the outside wall temperatures fall below the dew point of the trapped air and condensation will form and mould will follow soon after if left unchecked.
